Technical Report

**AIRFIELD MARKING PAINTS FOR
ASPHALTIC PAVEMENTS**

December 1970

NAVAL CIVIL ENGINEERING LABORATORY

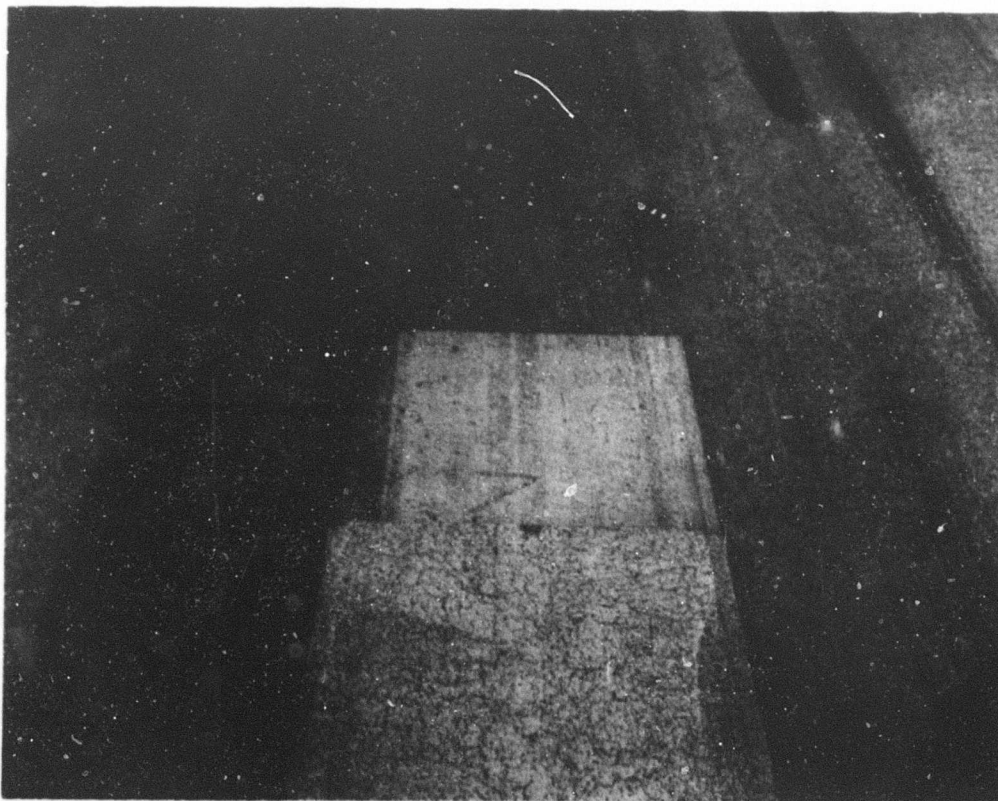
Formulation 114, water-emulsion polyvinyl acetate. This paint (Figure 8) had no cracking or chipping, and it had the best retention of glass spheres. Its erosion rating was as high as any of the others. Its reflectivity and general appearance ratings were probably affected more adversely by its greater touchdown of aircraft than those of the other paints.

Figure 8. Test plot of Formulation 114 at NAS, Agana 1 year after application.

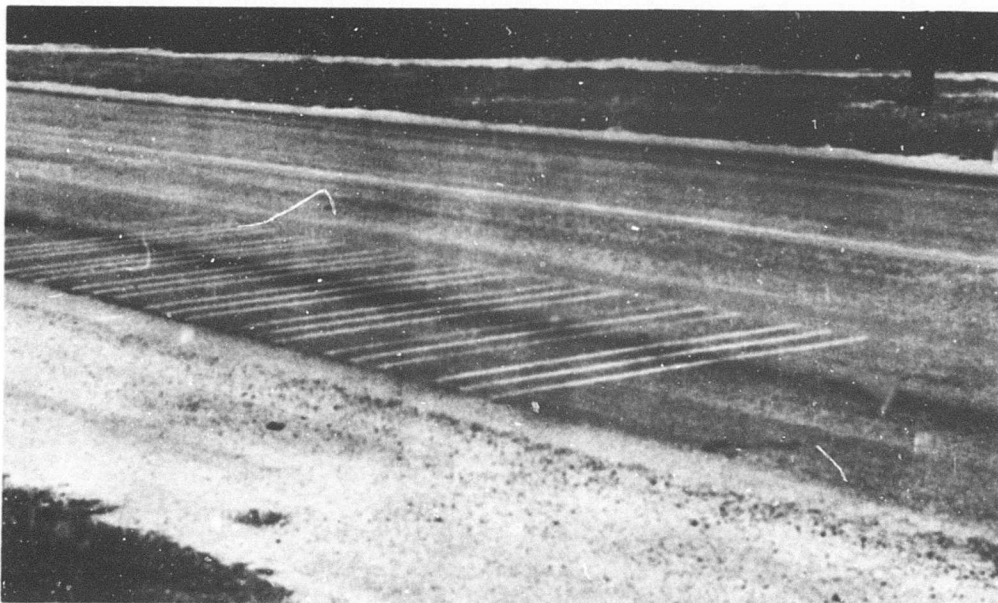
Figure 9. Roadway at USNS, Guam with the seven sets of painted stripes 1 year after application.

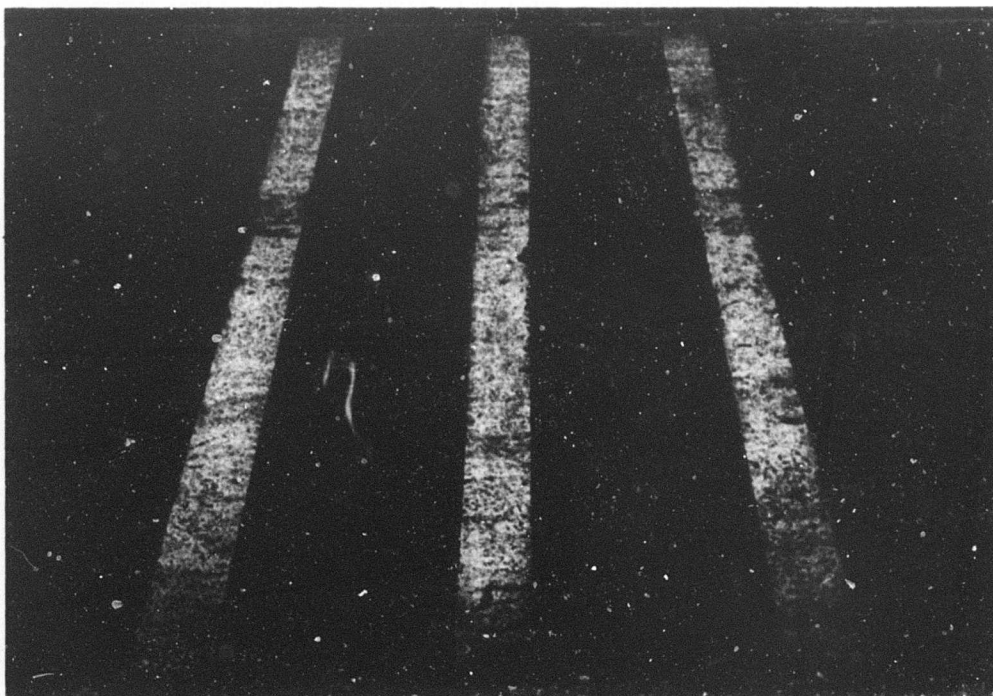
Figure 15. Set of stripes of Formulation A at USNS, Guam 1 year after application.
Left to right: single-thickness, reflectorized; double-thickness, reflectorized;
single-thickness, unreflectorized.

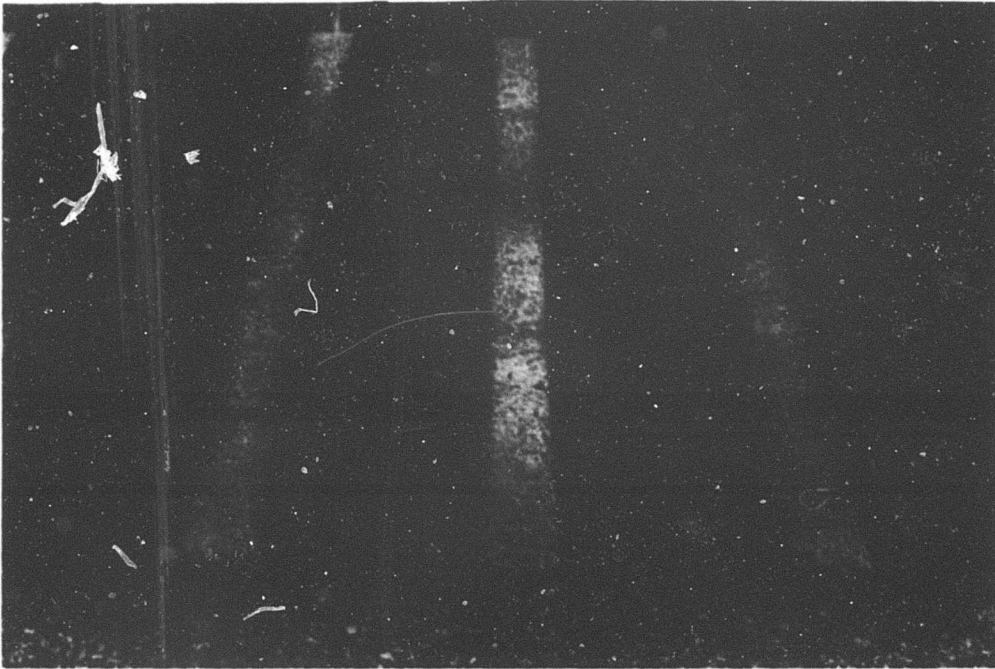
Figure 16. Set of stripes of Formulation 115 at USNS, Guam 1 year after application. Left to right: single-thickness, reflectorized; double-thickness, reflectorized; single-thickness, unreflectorized.
